The impact of electrocution on the New Zealand falcon (*Falco novaeseelandiae*)

Fox, N.C.; Wynn, C. 2010. The impact of electrocution on the New Zealand falcon (*Falco novaeseelandiae*). *Notornis* 57(2): 71-74.

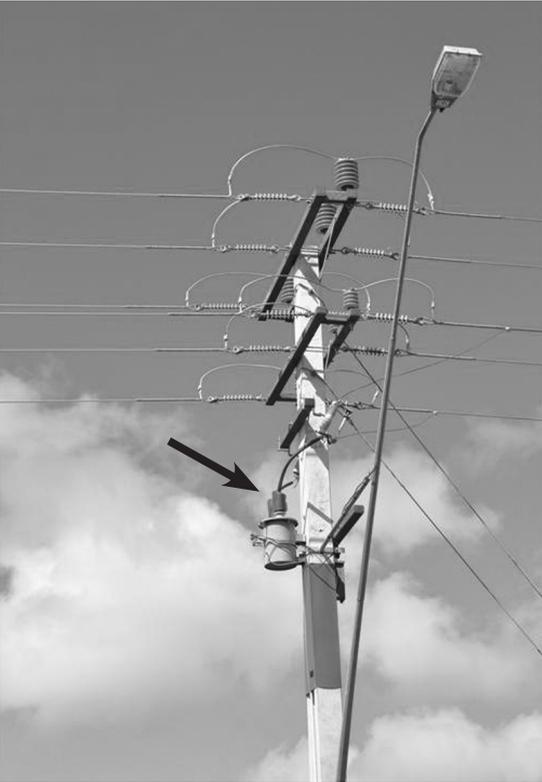
Fig. 1. Example of a electrical pole that electrocuted a juvenile male New Zealand falcon. The pole was later retrofitted with insulators (arrow) to prevent further electrocutions.

When a dead falcon was located, we determined the causes of death as best we could from the field signs and from marks on the body. Where electrocution was implicated, we noted the identification number of the pole, its longitude and latitude, and photographed the pole.

Thus 9 of the 12 poles associated with an electrocution involved transformers. As far as we know, no electrocuted falcons in our study survived.
